**Flood Control Project Maintenance
Levee Inspections**

Maintenance Issue Types Only, Levee Inspection Report By Mile - Spring 2017

California Department of Fish and Game Shea Levee

Waterway	Bank	Unit Miles	Inspection Start/End	Inspector
Unit No. 01 Sacramento River	Left	0.30	04/17/2017 04/17/2017	Bob Duffey

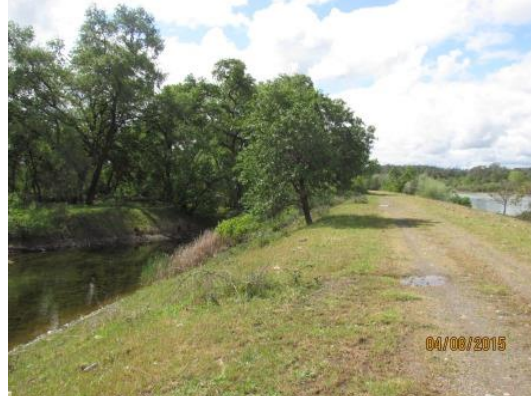
Photo 1 of 2 : SP_2017_NA0018_269_2_20170315_00002.jpg

LM Start	0.00	Rating **	M	Issue No.	2
LM End	0.07	Issue Type +	Ma	Location *	LS
Category	Earthen Levee			GPS Latitude/Longitude	
				Start	End
Item	Vegetation			40.508138 °	40.508138 °
				-122.363480 °	-122.363480 °
DWR ID	DWR_NA0018_01_s_2012_2				
Comment Code					
V2 : Remove the wild growth other than native grasses from the levee slopes.					
Inspector Comment					
California Department of Fish and Wildlife has not completed any maintenance this year.

View of the levee with no maintenance done.

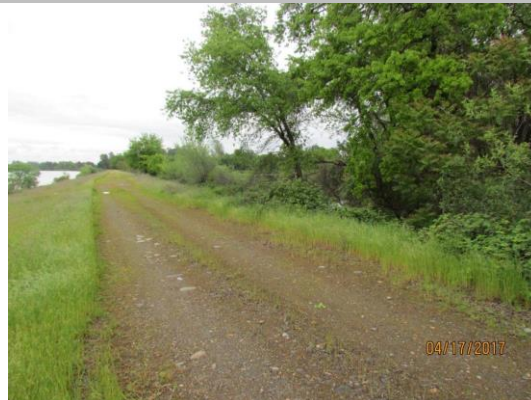
Photo 2 of 2 : SP_2017_NA0018_269_2_20170418_00006.jpg

View of the vegetation along the landside slope.

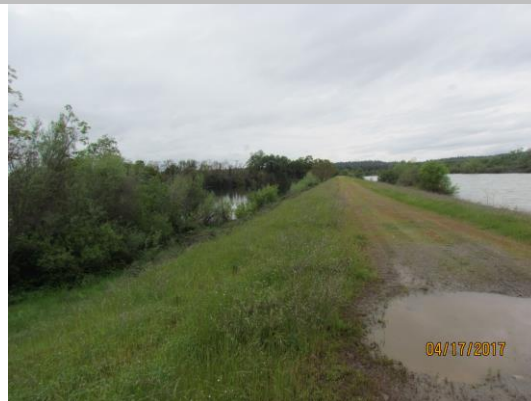
Photo 1 of 2 : SP_2017_NA0018_269_1_20170418_00007.jpg

LM Start	0.10	Rating **	M	Issue No.	1
LM End	0.30	Issue Type +	Ma	Location *	LS
Category	Earthen Levee			GPS Latitude/Longitude	
				Start	End
Item	Vegetation			40.511185 °	40.510670 °
				-122.360553 °	-122.361203 °
DWR ID	DWR_NA0018_01_s_2012_1				
Comment Code					
V2 : Remove the wild growth other than native grasses from the levee slopes.					
Inspector Comment					
Remove the vegetation from the landside slope.

View of the vegetation along the landside slope.

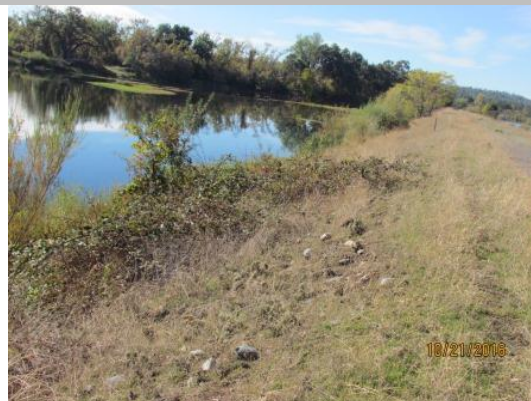
Photo 2 of 2 : SP_2017_NA0018_269_1_20170315_00001.jpg

View of the blackberries and other vegetation along the landside slope.

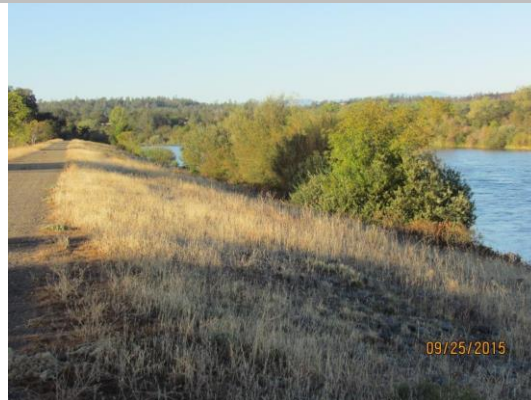
Photo 1 of 2 : SP_2017_NA0018_269_4_20170315_00005.jpg

LM Start	0.21	Rating **	M	Issue No.	4
LM End	0.26	Issue Type +	Ma	Location *	LS
Category	Earthen Levee			GPS Latitude/Longitude	
				Start	End
Item	Trim / Thin Trees			40.511518 °	40.508234 °
				-122.360100 °	-122.363430 °
DWR ID	DWR_NA0018_01_s_2012_4				
Comment Code					
T3 : Trim and thin trees to allow visibility of the ground and room to flood fight.					
Inspector Comment					
Trim the trees on the landside and waterside slope

Trim the trees along the waterside slope.

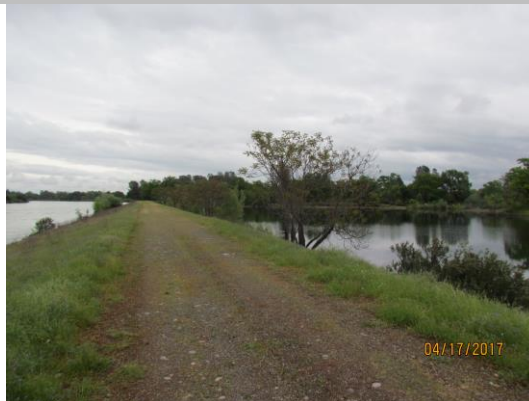
Photo 2 of 2 : SP_2017_NA0018_269_4_20170418_00008.jpg

LM Start	0.21	Rating **	M	Issue No.	4 (cont)	
LM End	0.26	Issue Type +	Ma	Location *	LS	
Category	Earthen Levee			GPS Latitude/Longitude		
				Start		End
Item	Trim / Thin Trees			40.511518 °		40.508234 °
				-122.360100 °		-122.363430 °
DWR ID	DWR_NA0018_01_s_2012_4					
Comment Code						
T3 : Trim and thin trees to allow visibility of the ground and room to flood fight.						
Inspector Comment						
Trim the trees on the landside and waterside slope

Trim the trees along the landside and waterside slope.
